BUREAU OF SHIPS GROUP TECHNICAL INSPECTION REPORT

⑥ OPERATION CROSSROADS.
SAKAWA (E_x J_ap CL)

TEST ABLE ^⑧LU.

SAKAWA (Ex Jap Cruiser)

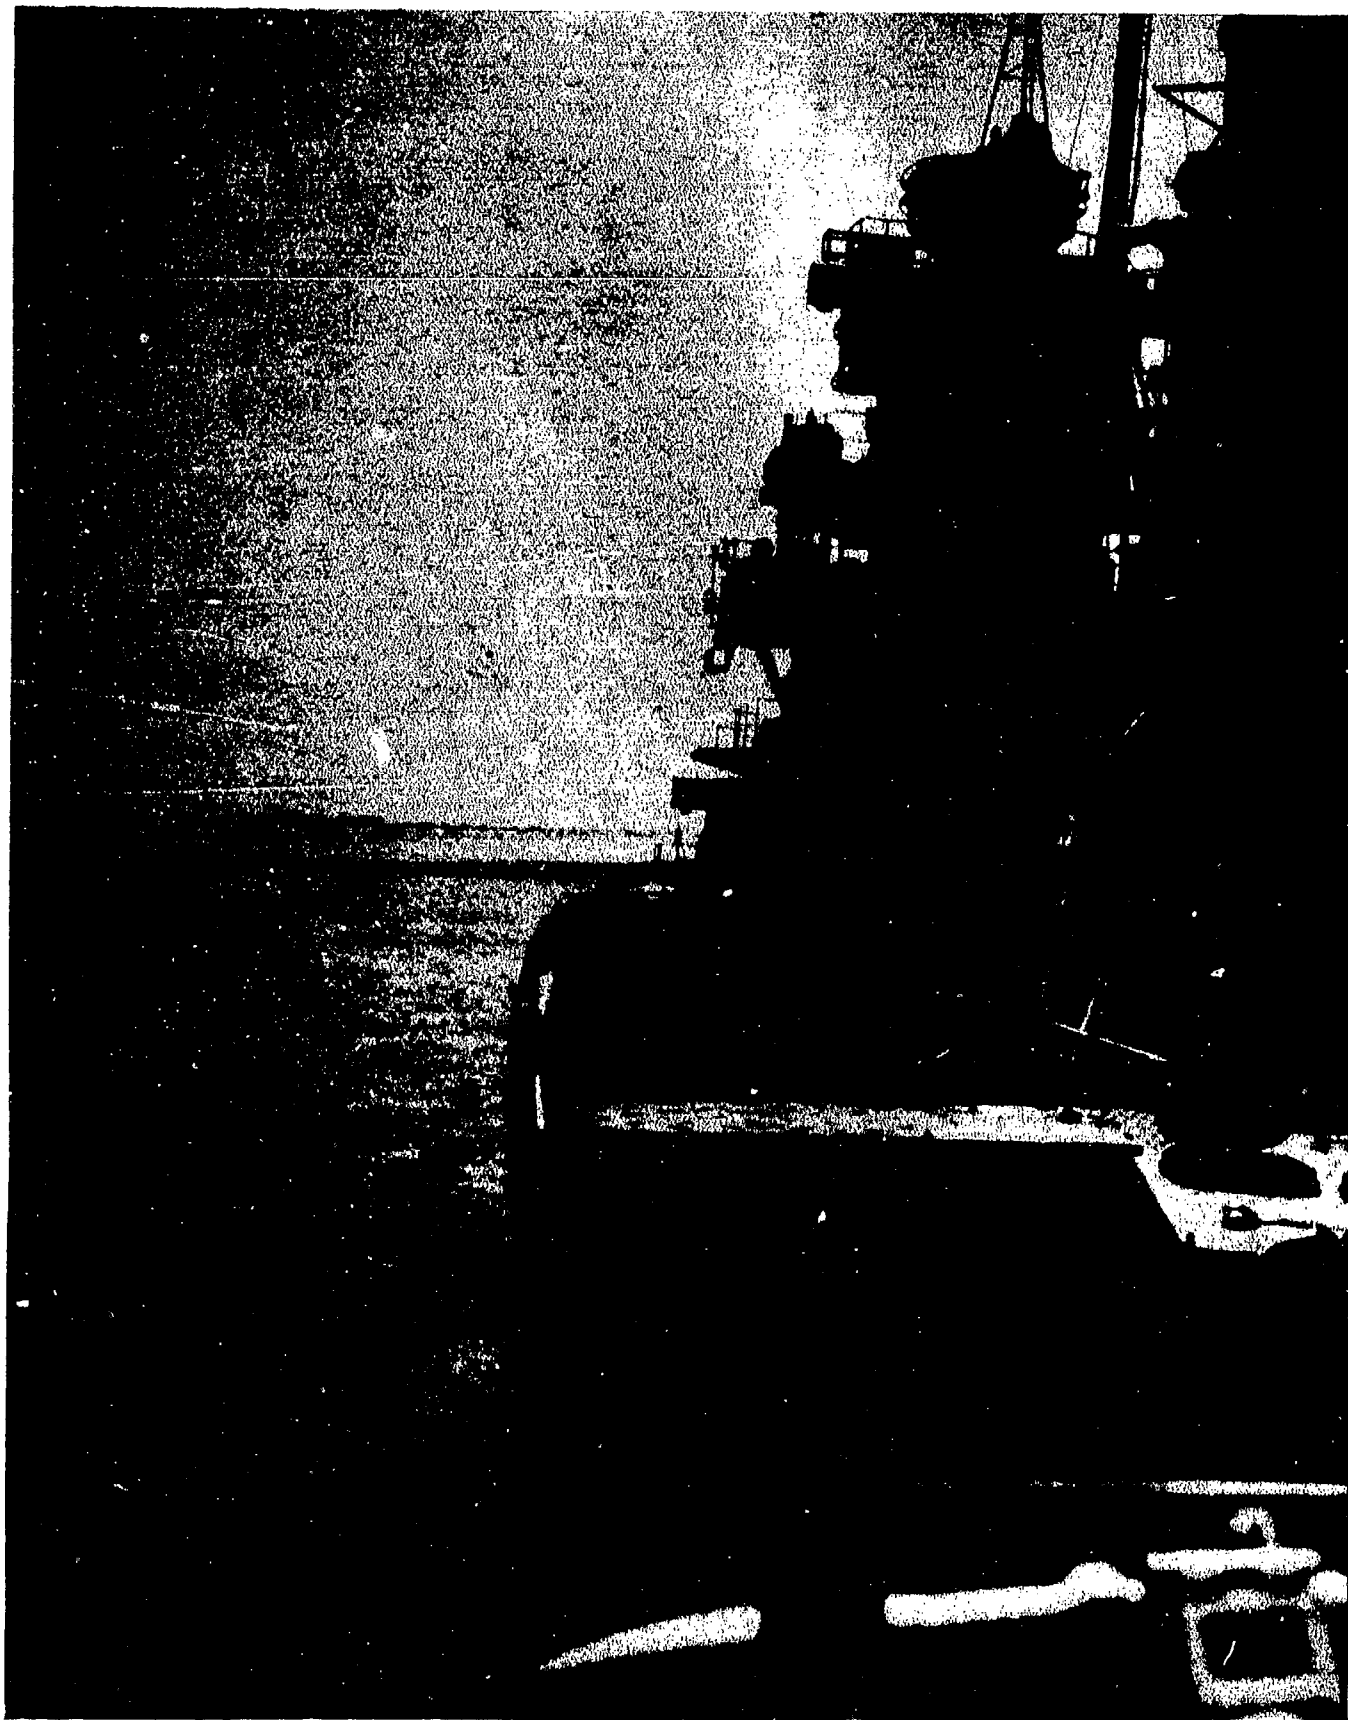
6872

BuAer Photo (19 April 1946). Pre-test view of SAKAWA'S bridge superstructure taken from the port side of deck house structure at about frame 108 aft.

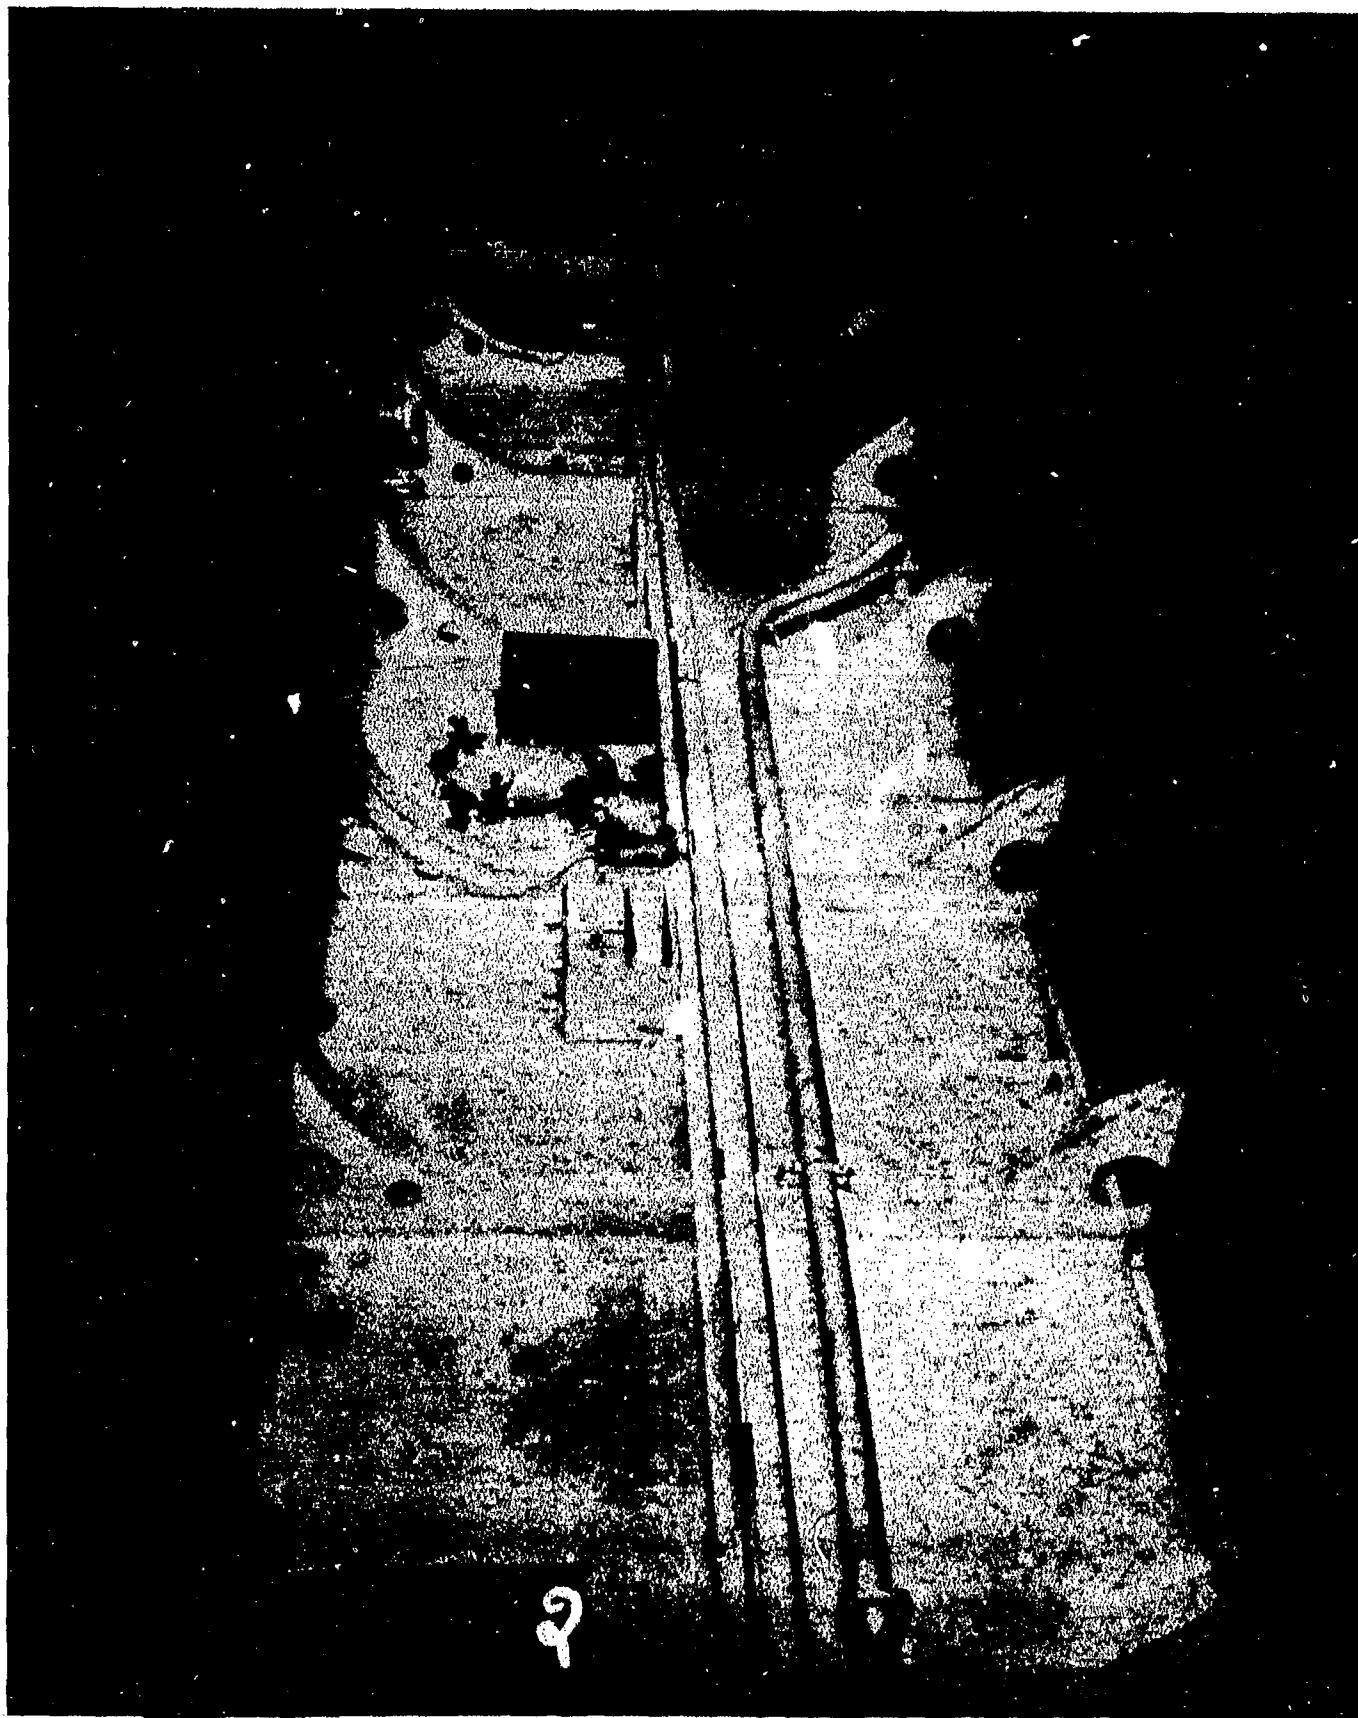
BA-CR-66-578-2. Details of longitudinals and transverse framing on SAKAWA. Picture taken before test on second deck, frame 129 to 134, starboard.

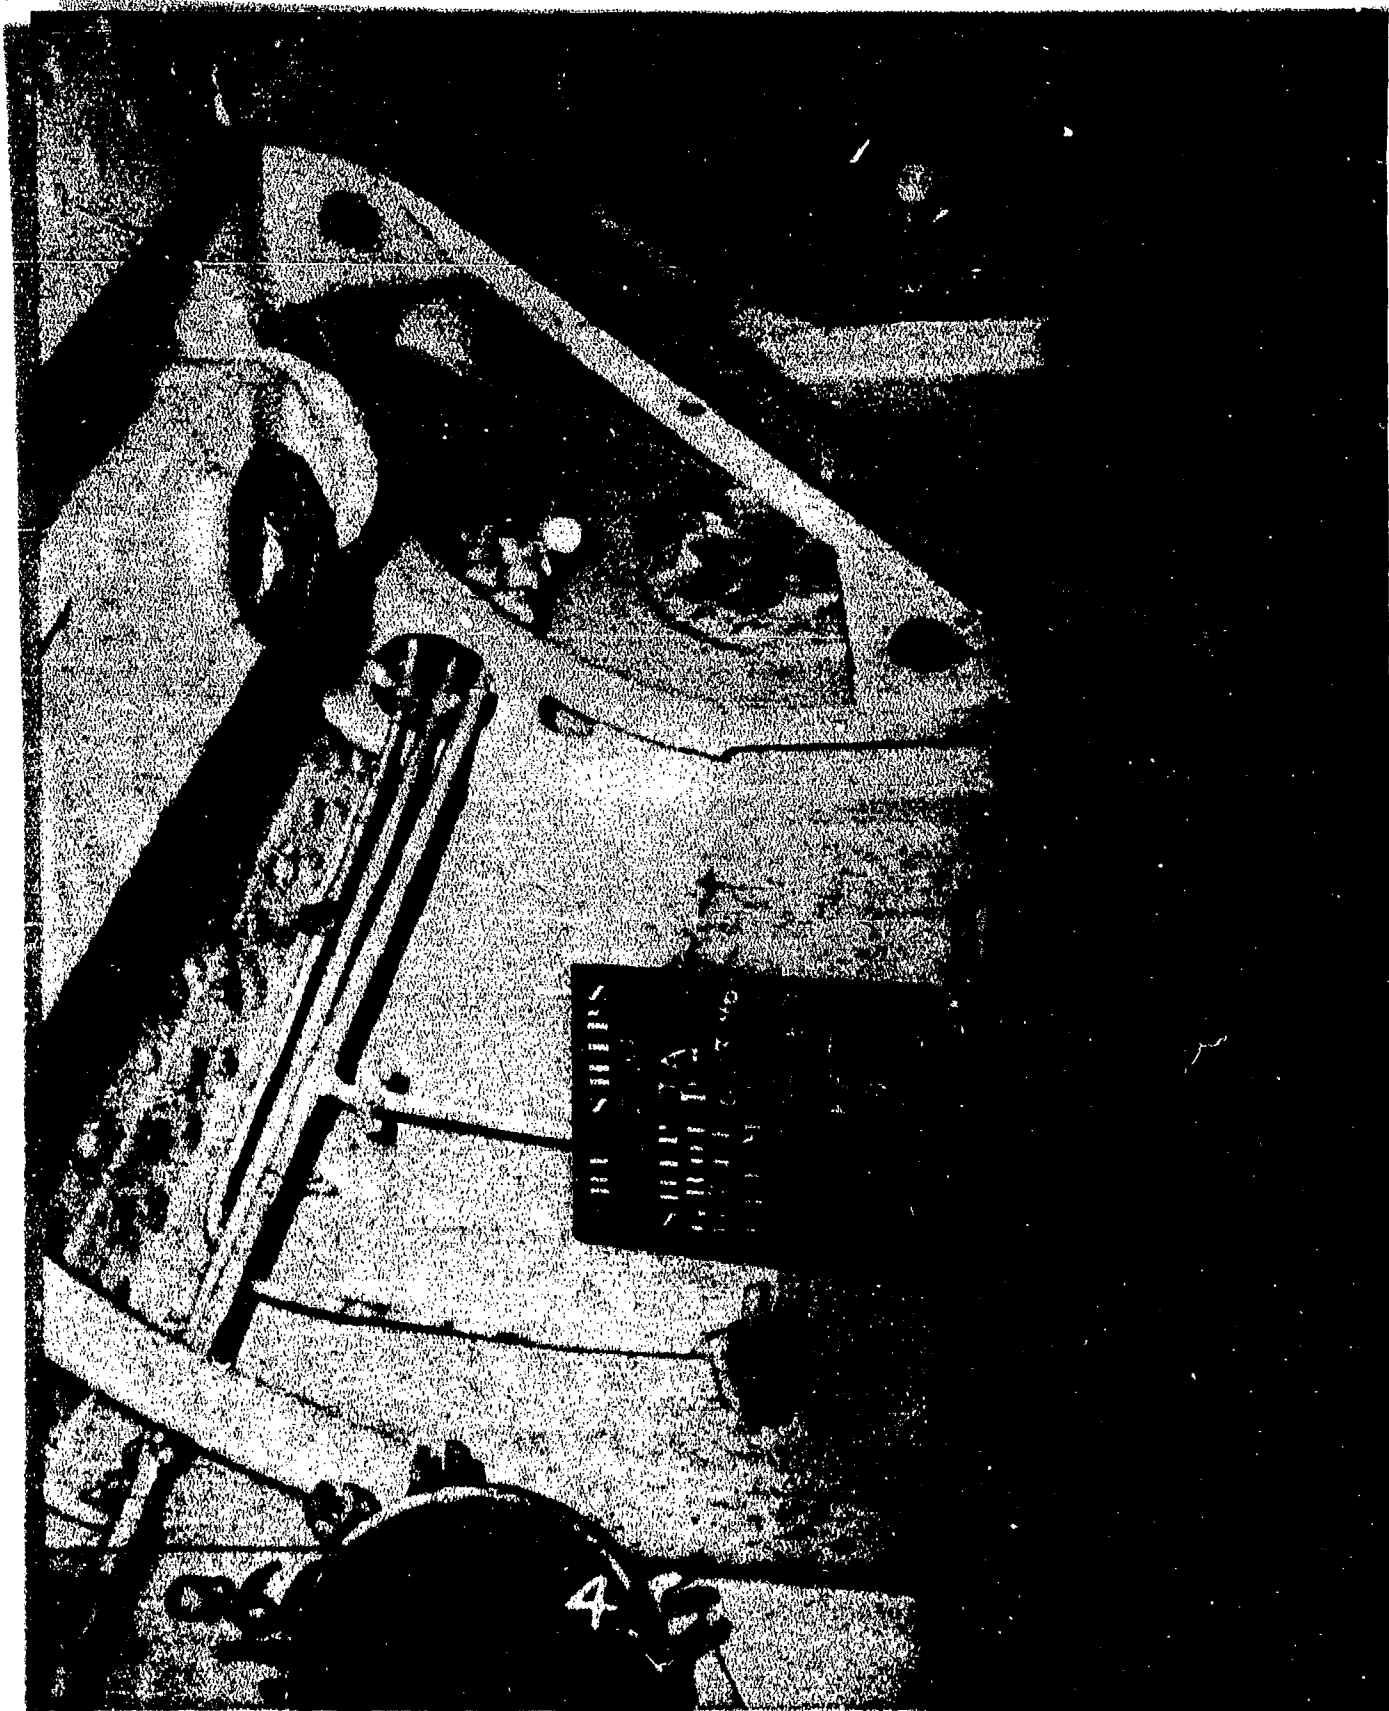
BA-CR-66-578-4. Reinforced bracket, frame 91, starboard side, second deck. Picture taken before test.

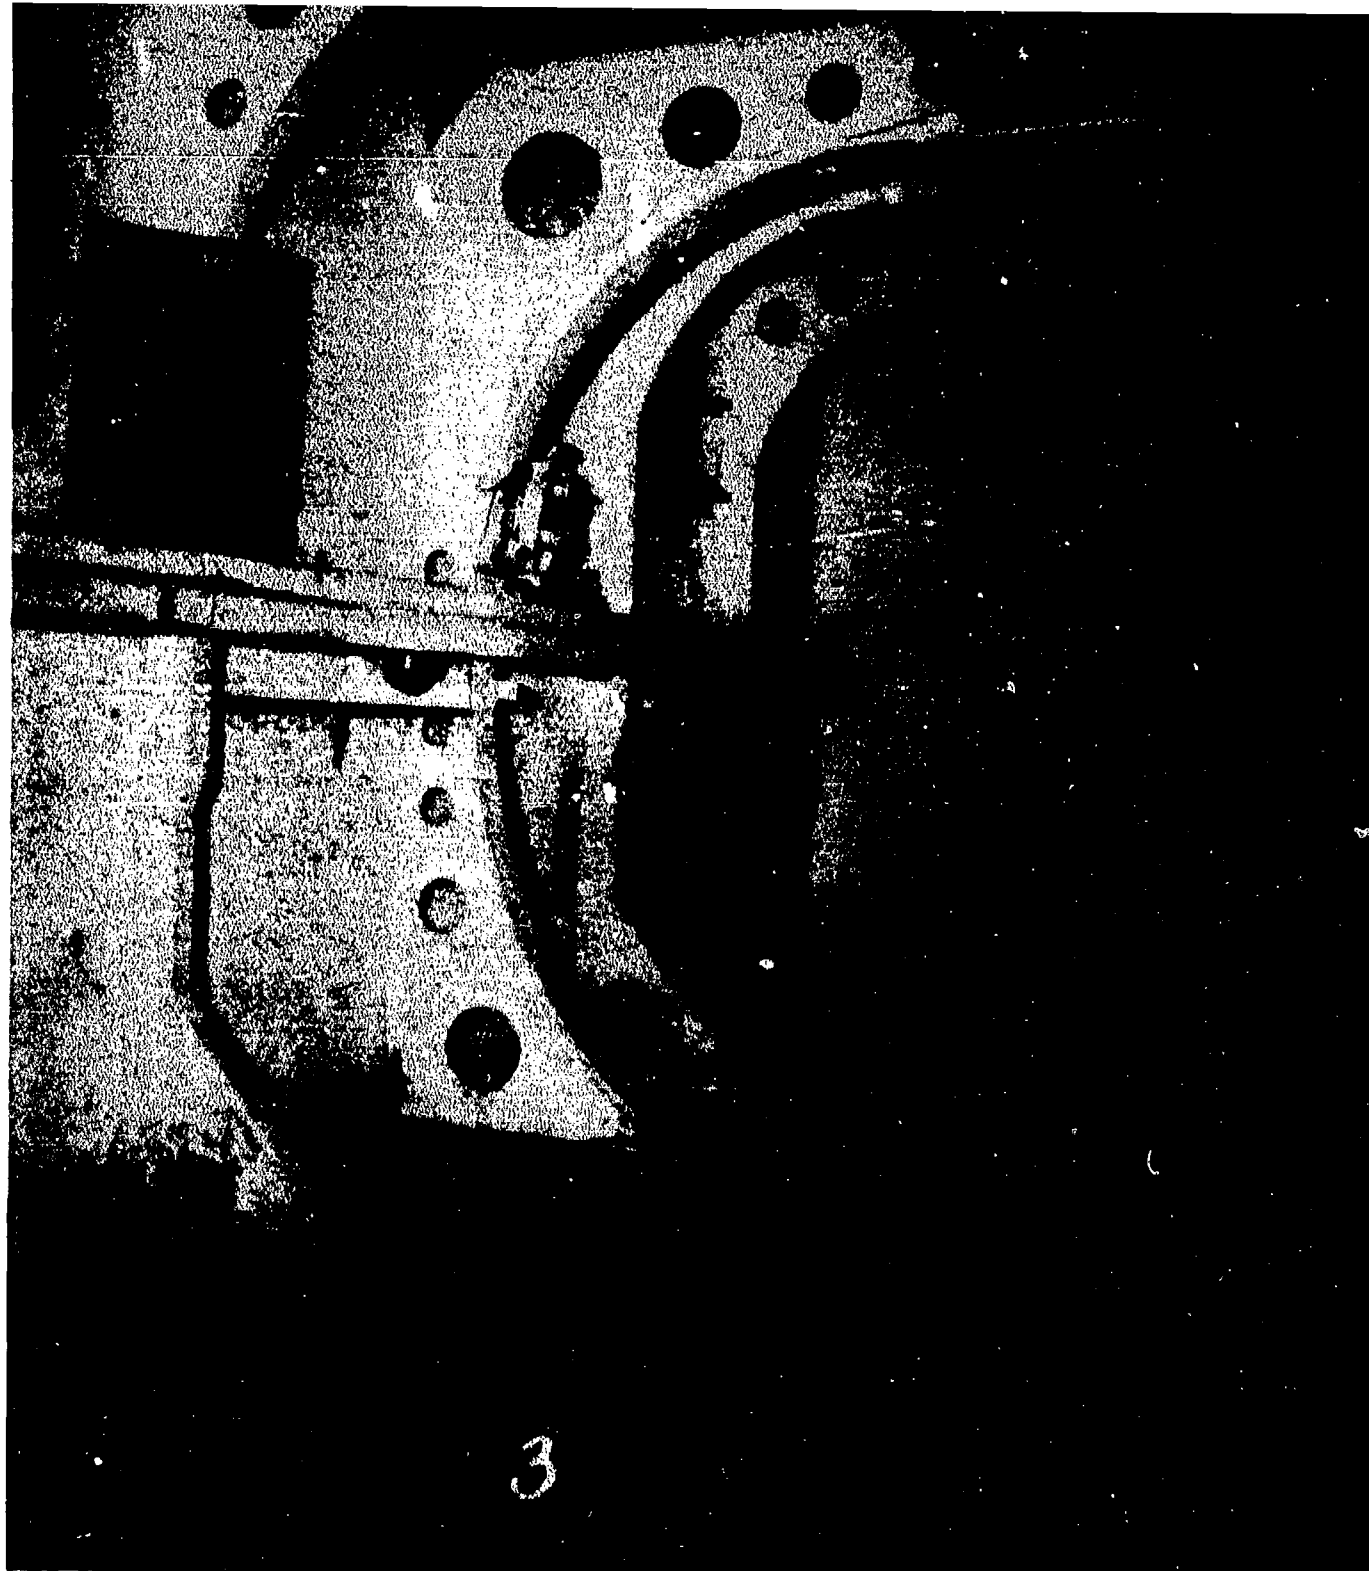
BA-CR-66-578-3. Web details, frame 146, starboard side, second deck.
Picture taken before test.

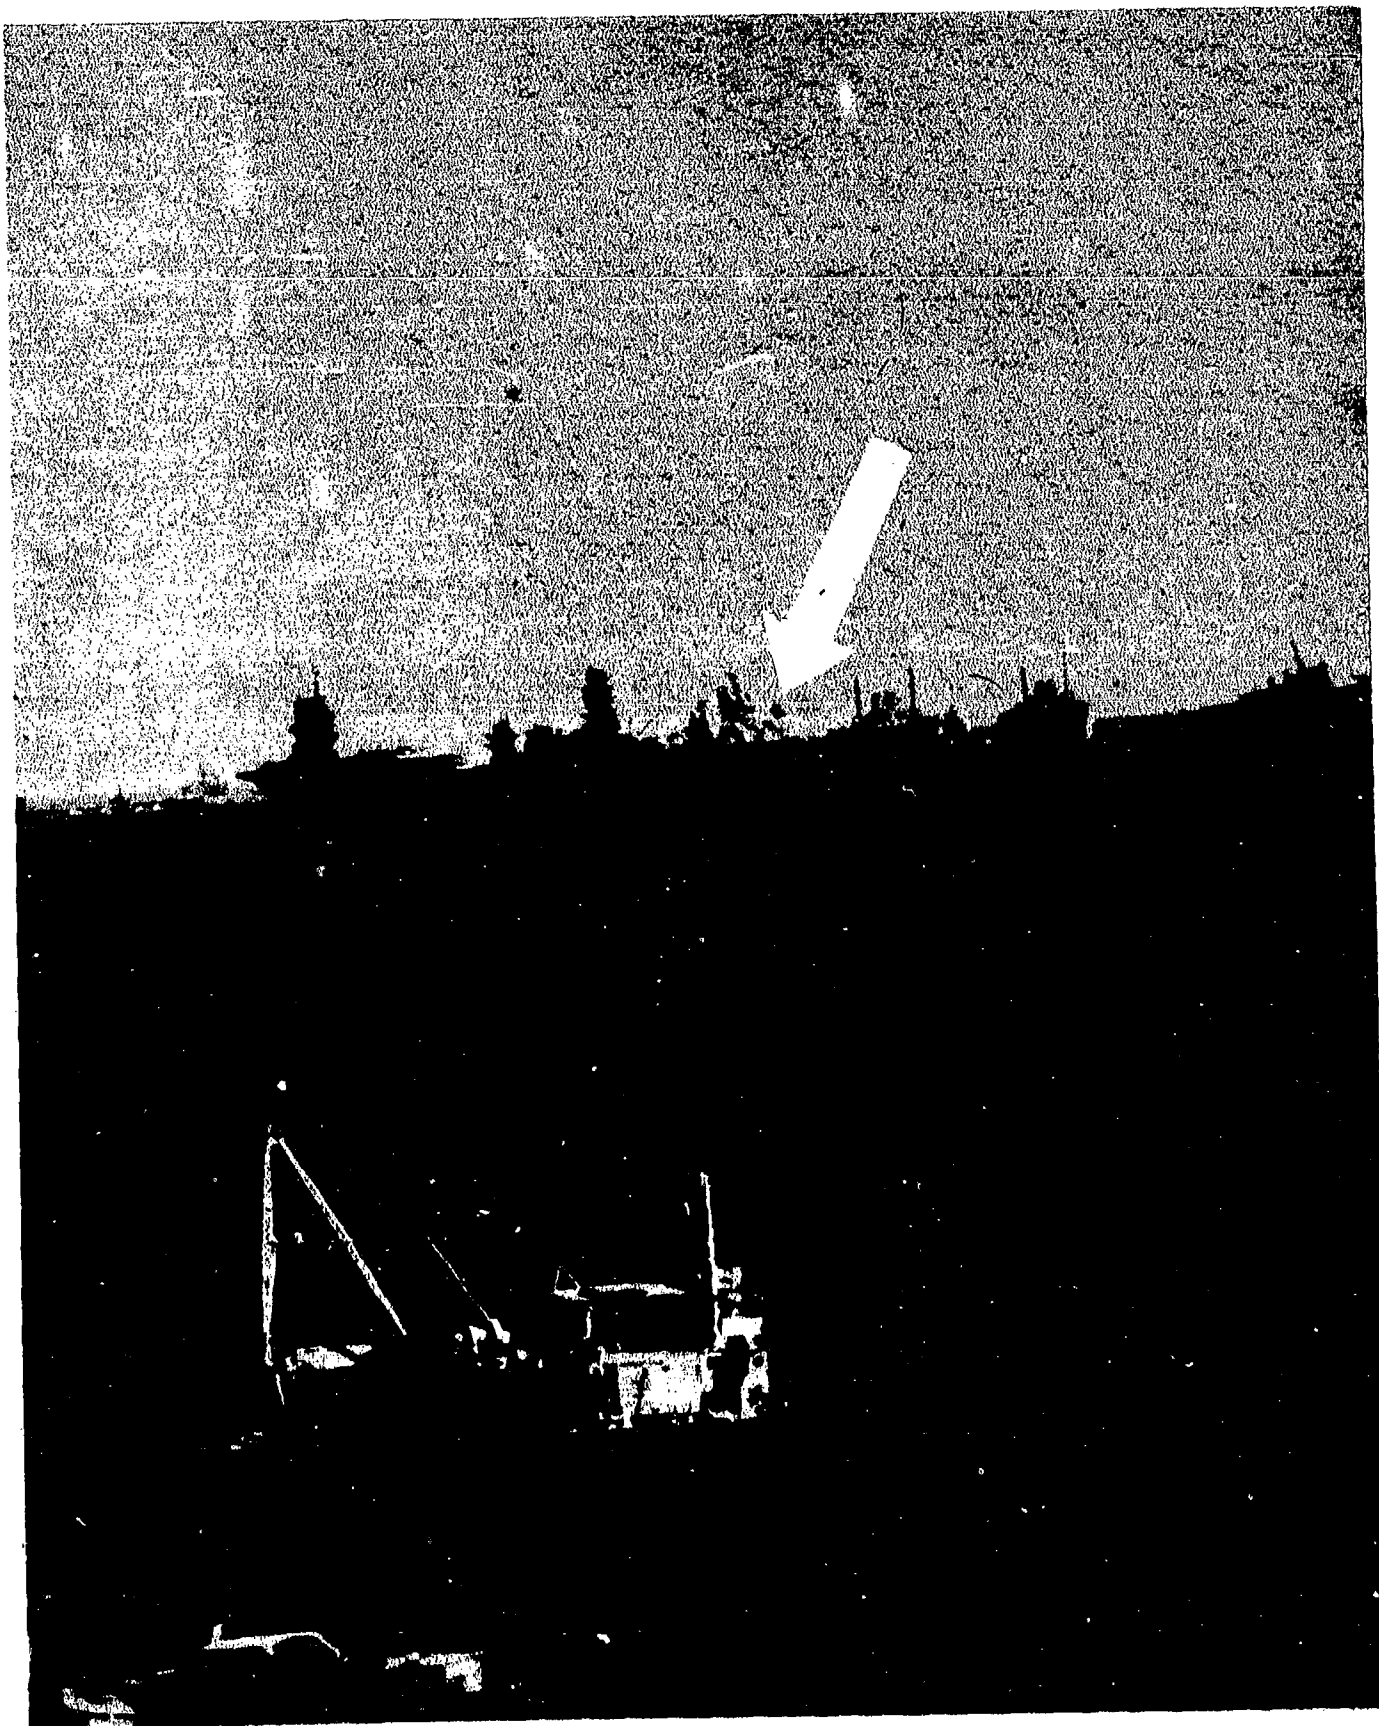
DA-CR-T3A-31/79 (-11) 1 July 46/40''/Bikini/Secret. Print #1. Target positions three seconds before Able burst as viewed from Enyu Island. From left to right: NAGATO, NEVADA, BRISCOE, STACK, and BANNER. SAKAWA superstructure can be seen (arrow) behind NEVADA.

Air blast as evidenced by direction of crumpling and falling of SAKAWA'S ravaged topside structure evidently struck from above and slightly to starboard of dead astern. A comparison of photos page 26 and page 27 show lateral displacement of SAKAWA by blast.
